CHURCH OF THE HOLY SEPULCHRE JERUSALEM

STRUCTURAL SURVEY
FINAL REPORT

BY
WILLIAM HARVEY

1935

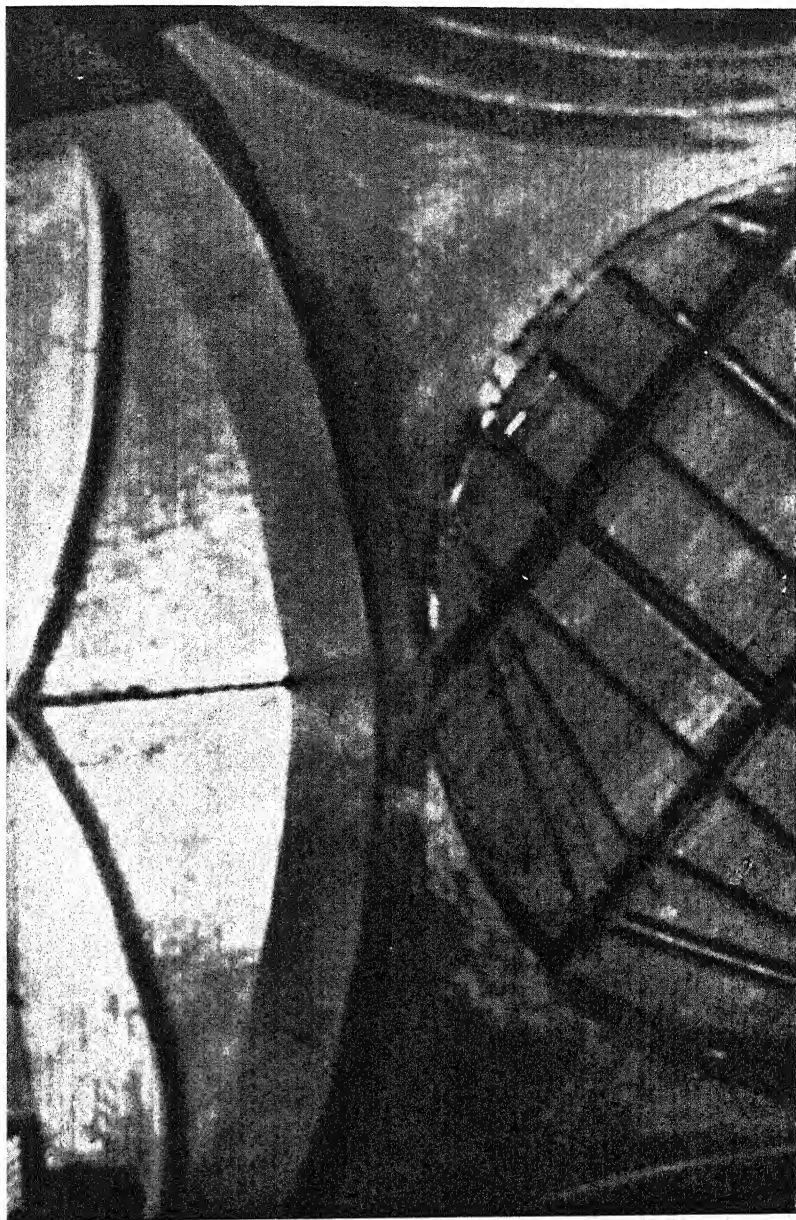
FIG. 1. EASTERN PENDENTIVES FROM BENEATH

The thrust is first communicated in a direction both downward and outward to the pendentives (see Figs. 1, 2, II, 24) supported on the four great arches of the crossing. It is to the position of the dome above the pendentives that the outward thrusts must be ascribed (see Fig. II).

The pendentives (see Figs. 1, 2, II, 24) receive the weight of the dome and transmit it to the four main piers below, but there is also considerable outward thrust, as the pendentives are not vertical, but inclined inwards to the bottom of the drum above. They were completely plastered over after the fire of 1808, and do not themselves show signs of great movement, except in the North-west pendentive, which is badly cracked. The piers below have decided leans outwards in the upper portions, and from this inclination the further parts of the building have received the damaging thrusts (see Additional Notes, p. 14).

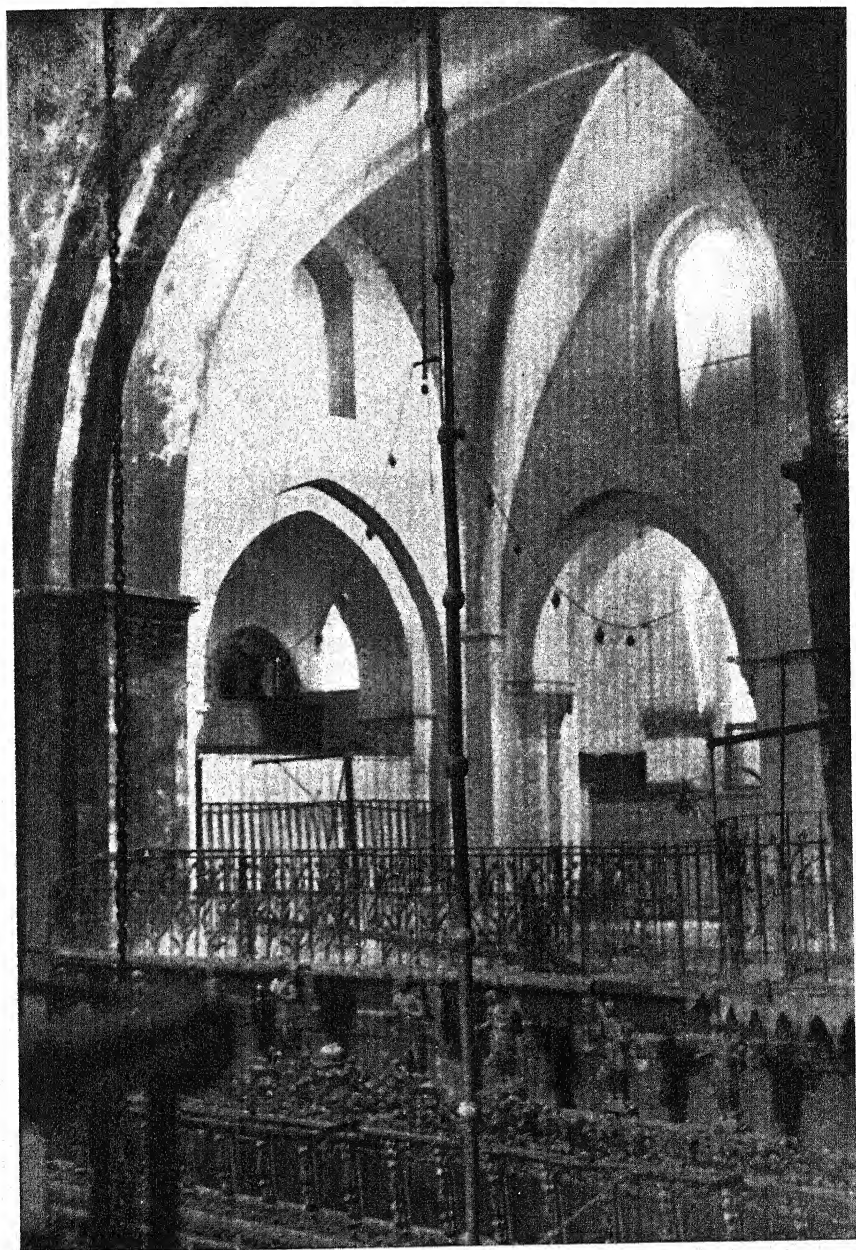
FIG. 3. NORTH TRANSEPT HIGH VAULT FROM S.E.

The North Transept proper consists of only one bay, with a vault above the main springing level of the great arches, and consequently occupying the same vertical space as the pendentives of the dome (see Figs. 3, I, 3). To the north of this bay is a gallery with two floors (see Fig. II, 9)—both originally of Byzantine construction; the lower vault (see Fig. 4) being below the Triforium arcades of the Transept proper. The upper vault (see Fig. 5) is above the Triforium, while leaving a clerestory lighting the high vault of the Transept above (see Fig. 6). This higher vault of the gallery is therefore in a position to receive

the full thrust of the springing of the high vault (see Fig. 3) which it communicates to the North wall of the gallery, here an exterior wall of the Church. This wall contains the most dangerous evidence of movement in the building (see Fig. IV). For the lower half of its height, its outward inclination is approximately 1 in 60, but above this, for three metres below the sills of a series of windows lighting the upper gallery, it becomes rapidly sharper, reaching 1 in 20 and even 1 in 16. This is the more serious in that this upper walling contains work of several periods, ill bonded together, and much of the mortar has disappeared (see Fig. 7).

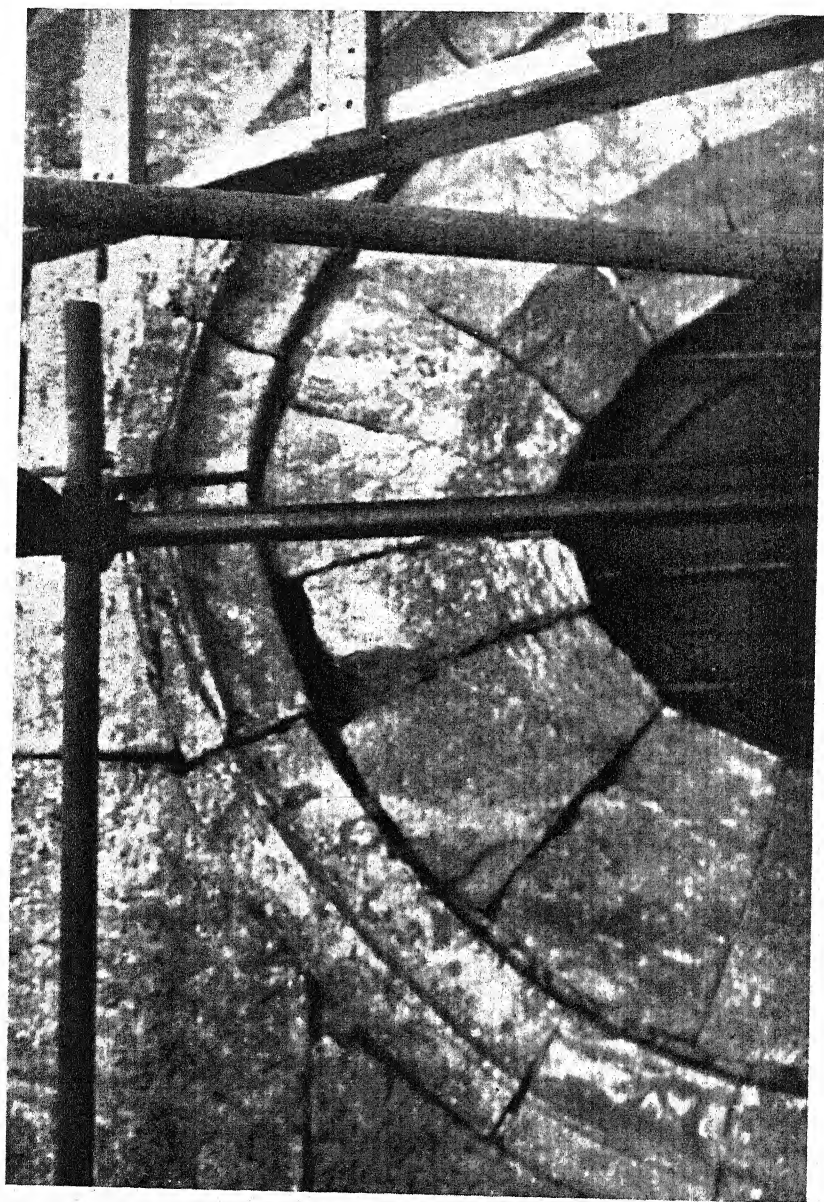
FIG. 8. A WINDOW-HEAD—NORTH WALL

Several instances occur of wide open joints penetrating through more than half the thickness of the wall, while the inner courses of voussoirs to the window arches have fallen downwards, leaving a wide space below the higher masonry (see Fig. 8). As the wall is restrained at each end by other buildings, leaving less than thirteen metres free to move outwards, such a grave inclination in the centre has resulted in great curvature of the wall-top (see Fig. 9) and this, together with the overhang and poor state of the mortar joints, may at any time allow the fall of some of the facing stones—should this occur any attempt to save the rest of the wall would be extremely dangerous, and collapse of the high vaults behind might easily follow.

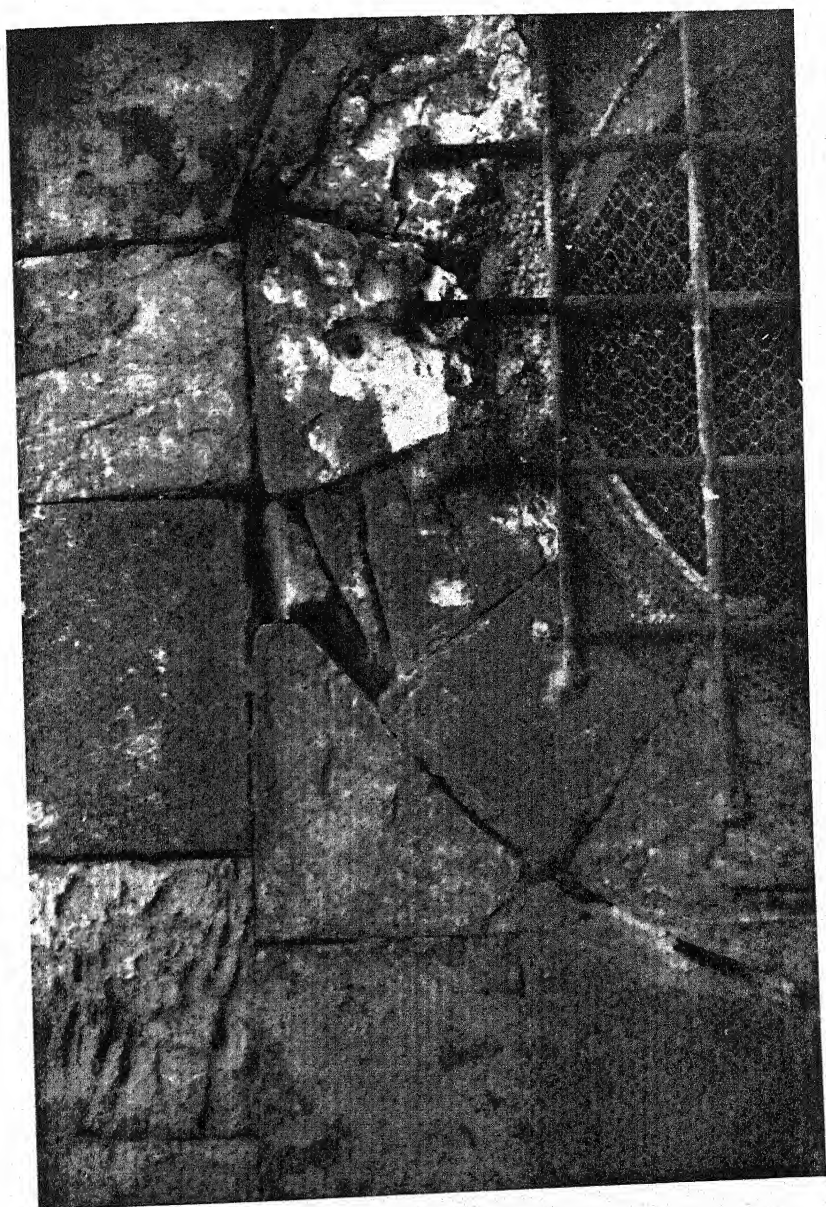
FIG. 13. NORTH TRANSEPT HIGH VAULT. E. WALL

The high vault itself (see Fig. 11) has also been plastered, but some two years ago a large stone fell from one of the main ribs, and the upper walls, where accessible from outside, are in an extremely poor condition (see Figs 12, 13, 14), many joints being completely denuded of mortar, and much of the masonry cracked and suffering from erosion, and to some extent from the effects of the fire of 1808.

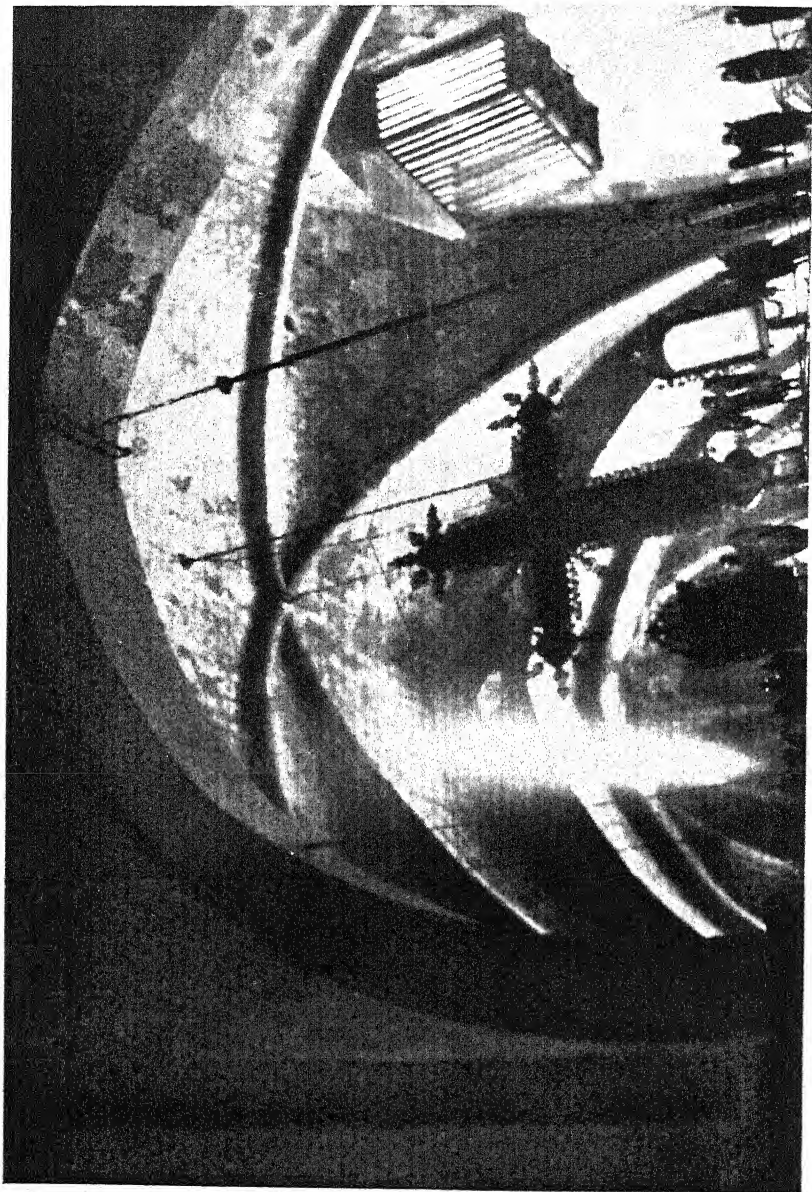
FIG. 16. EASTERN ARM HIGH VAULT FROM W.

The Eastern arm of the Church dates from the twelfth century, but the work is obscured by the plastering and additions of 1810 (see Figs. 16, 17, I, 5-II, 2). The apse (see Figs. I, 6-II, 3) is divided into two stories, of which the lower probably retains a twelfth-century core, while the upper is completely of the 1810 rebuilding. While the lower work remains upright, owing to the buttressing effect of many low vaults entirely surrounding it, the upper work is in a bad state of disrepair (see Fig. 18).

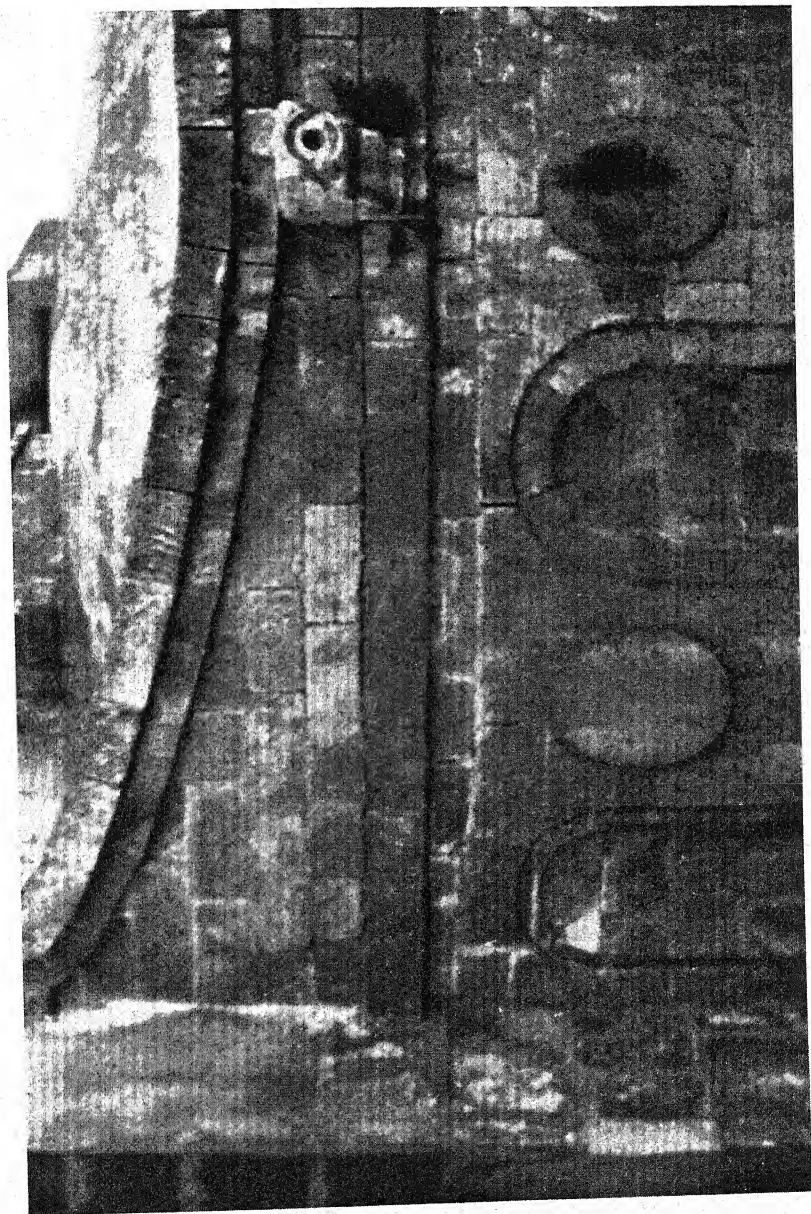
FIG. 19. APSE PARAPET

Near the apse roof, the bed-joints of several courses are devoid of mortar (see Fig. 19), and the parapet, unrestrained by any tie-bars, has moved outwards (see Fig. 20).

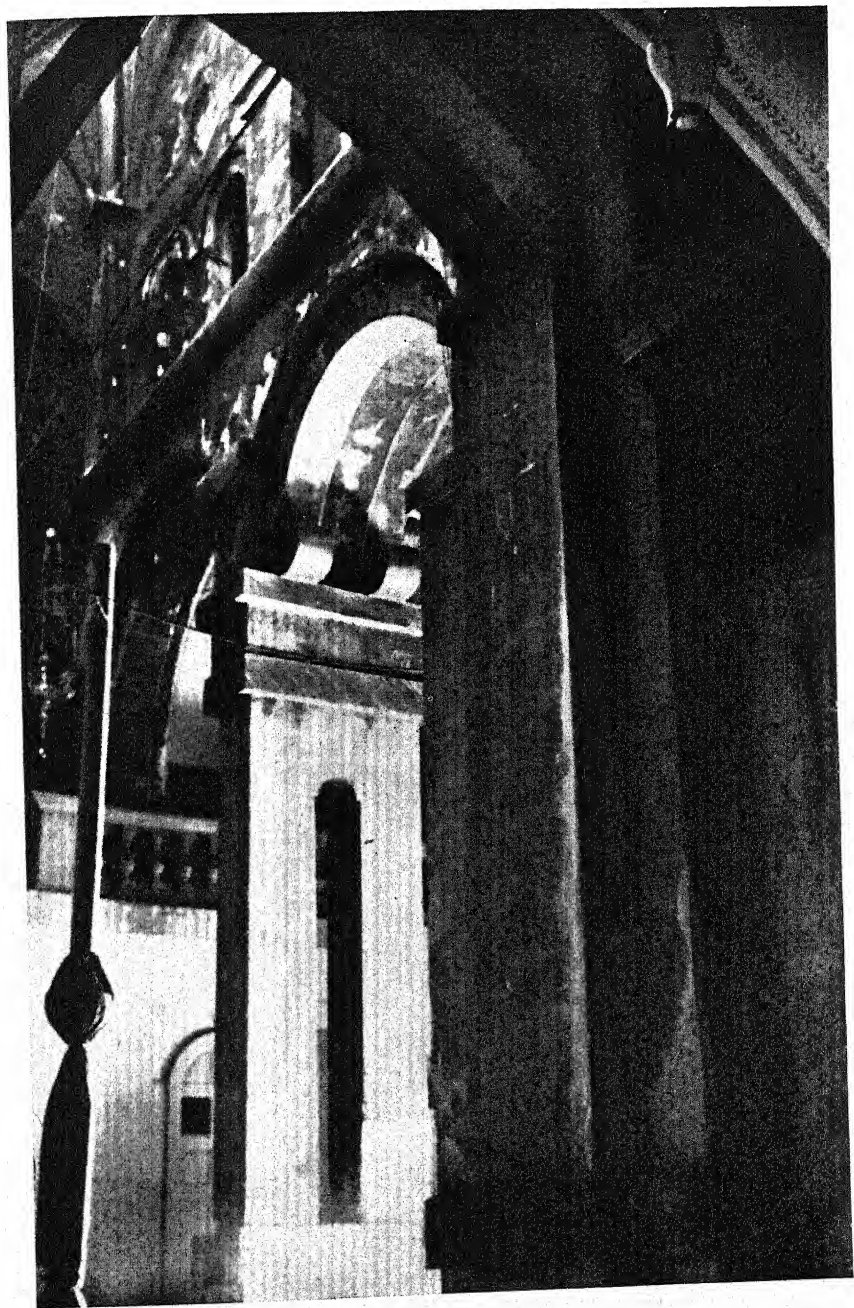
FIG. 21. SOUTH TRANSEPT FROM N.W.

The South Transept (see Figs. I, 1-II, 2), including the main front of the Church, contains much twelfth-century work; but the interior suffered greatly from the fire, and was partly rebuilt (see Figs. 21, 22, 23). The South wall shows very considerable calcining of the masonry, principally in the upper story, and a large proportion of the stonework is unfit to support the superincumbent weight and thrusts.

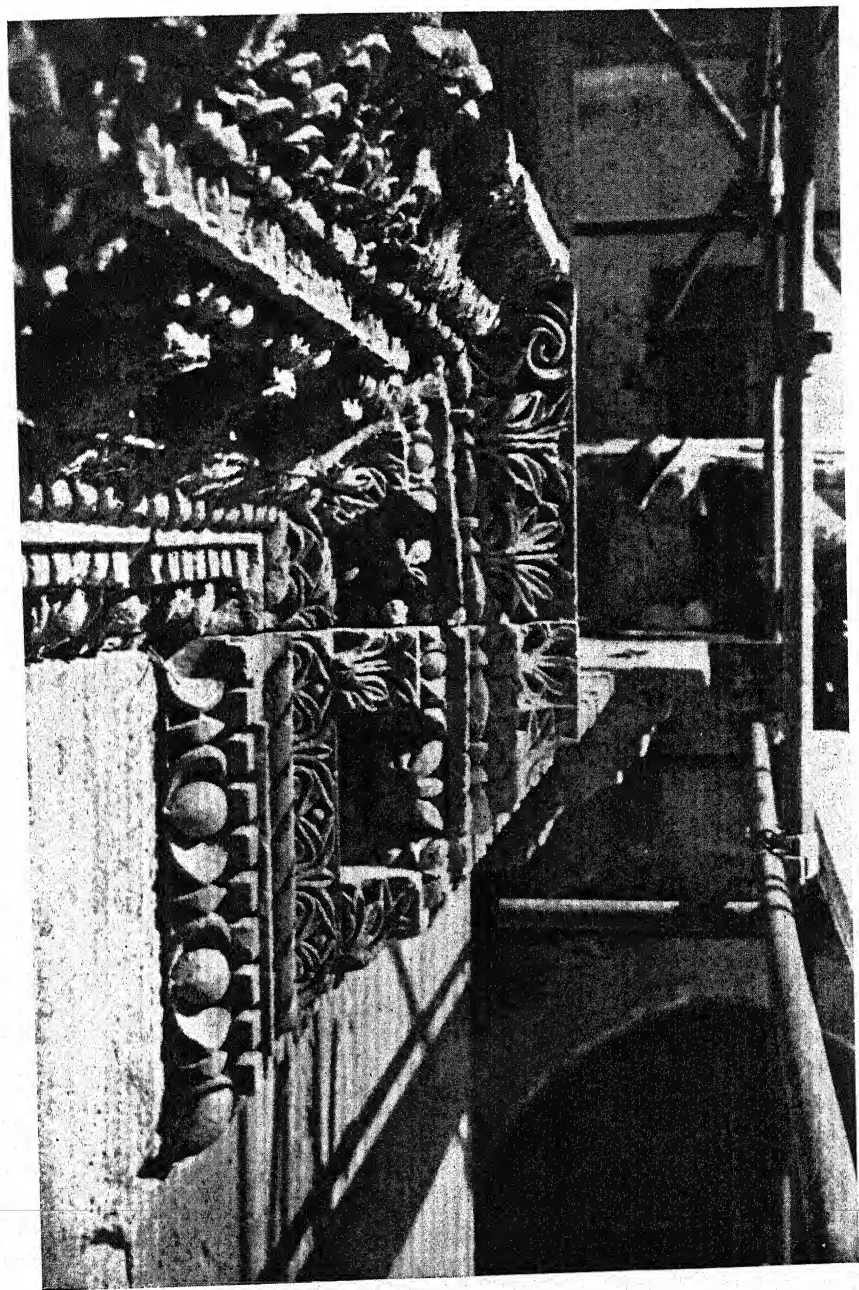
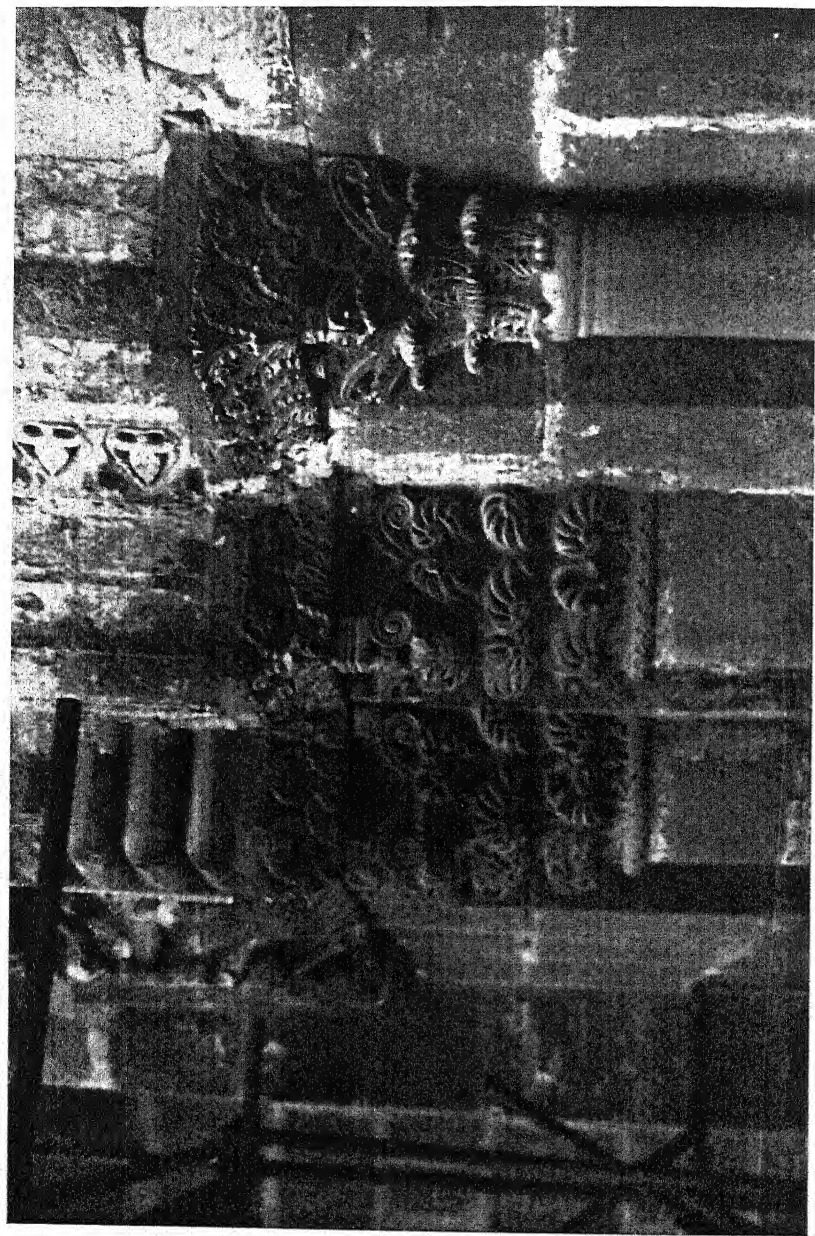
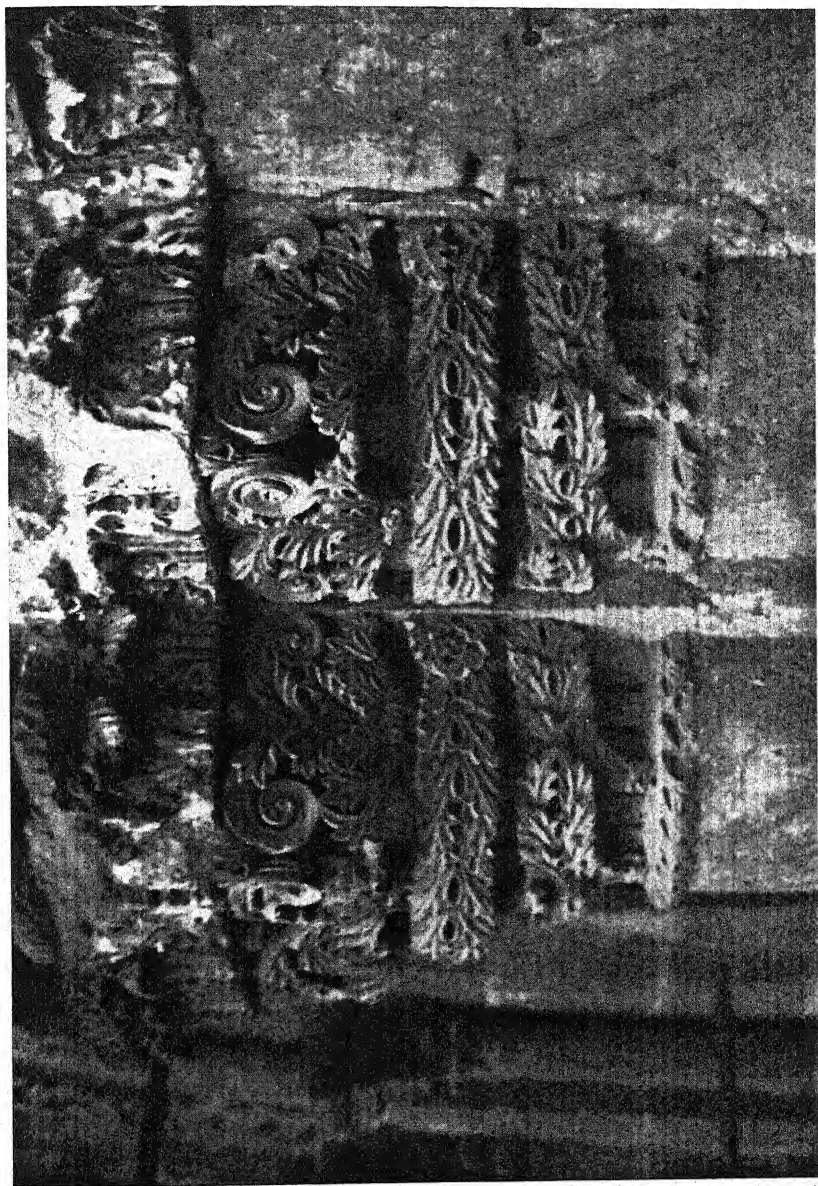
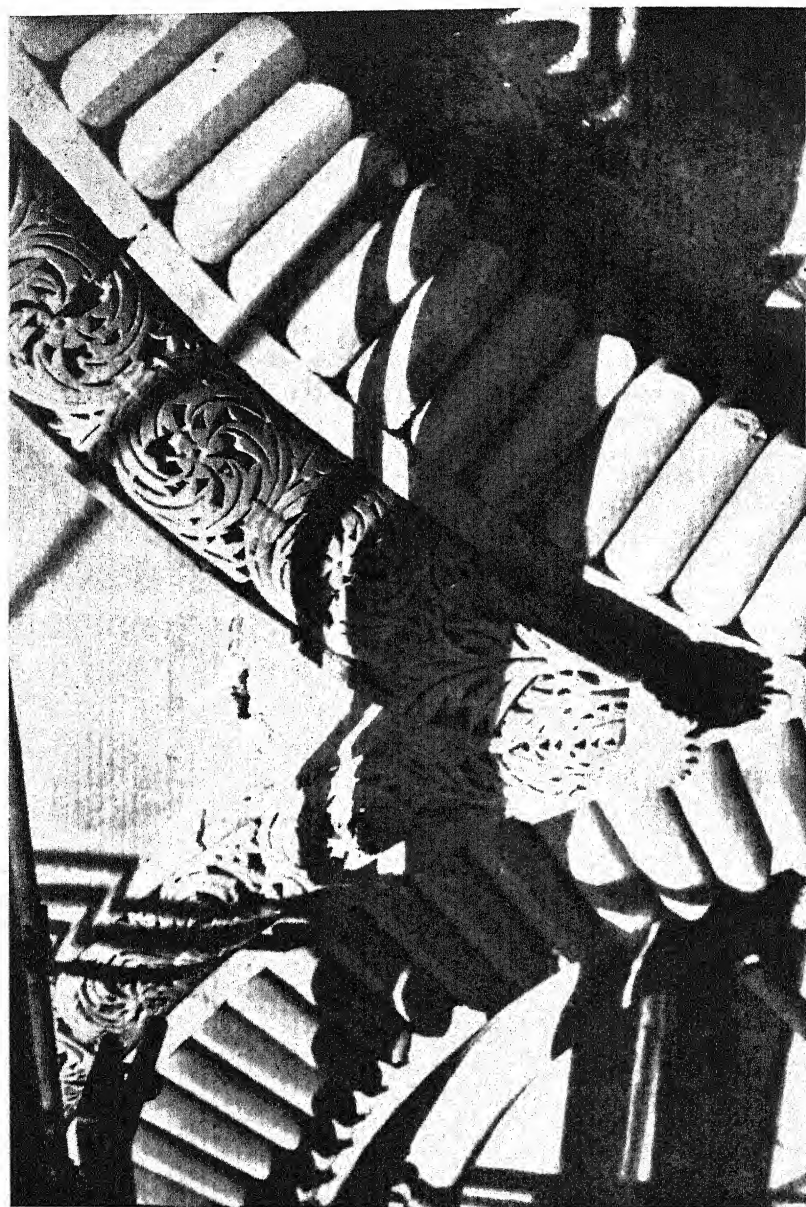
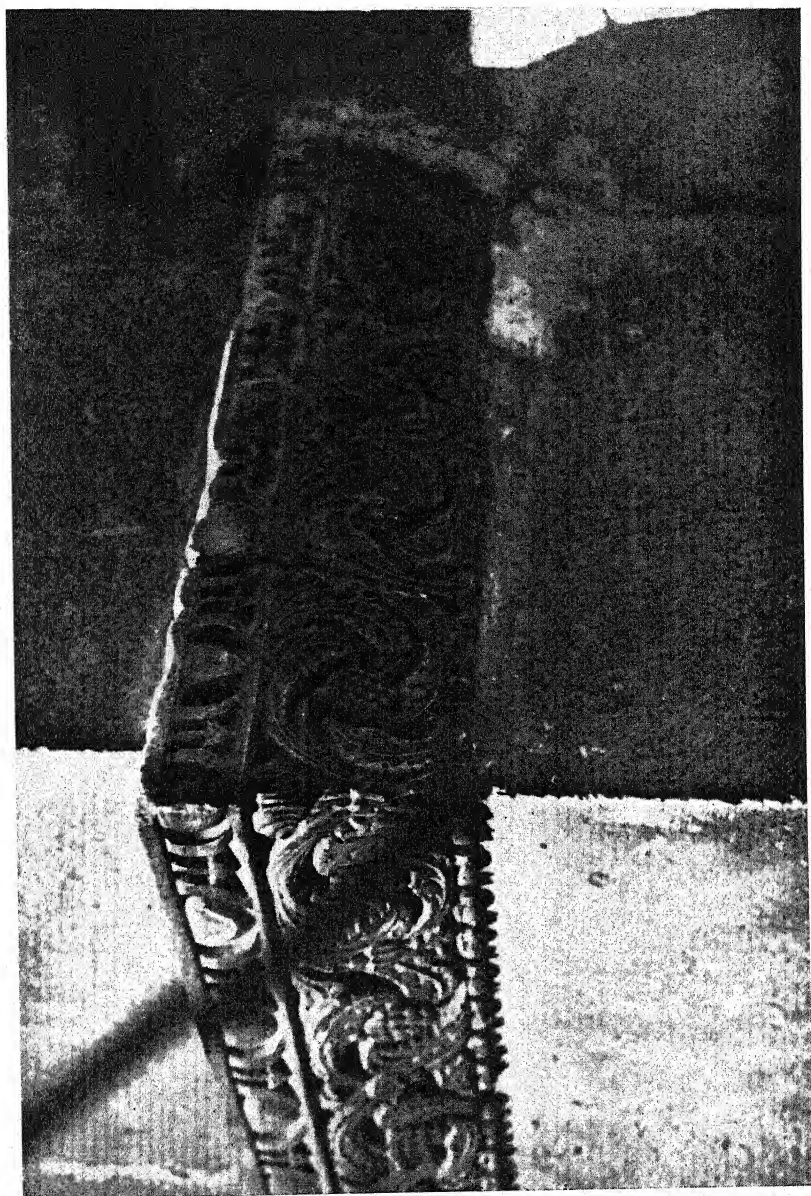
The lower colonnettes and their bases are almost all cracked, the oblique direction of the cracks showing the asymmetrical loading of the arches above (see Fig. 24). The condition of most of the carved work is extremely good (see Figs. 25, 26, 27, 28, 29) with the exception of the inner orders of the upper arches, which suffered most from the fire (see Figs. 30, 31, 32).

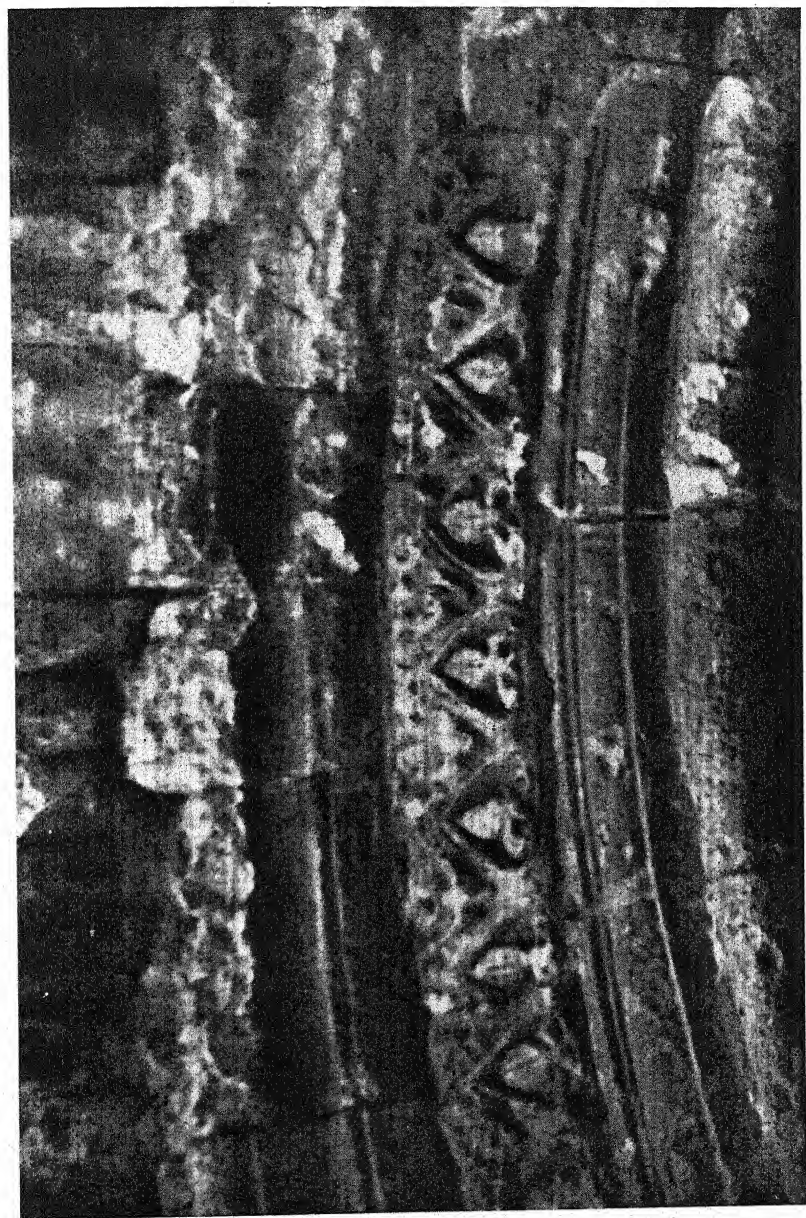
FIG. 31. PART OF CALCINED MOULDINGS TO UPPER ARCHES

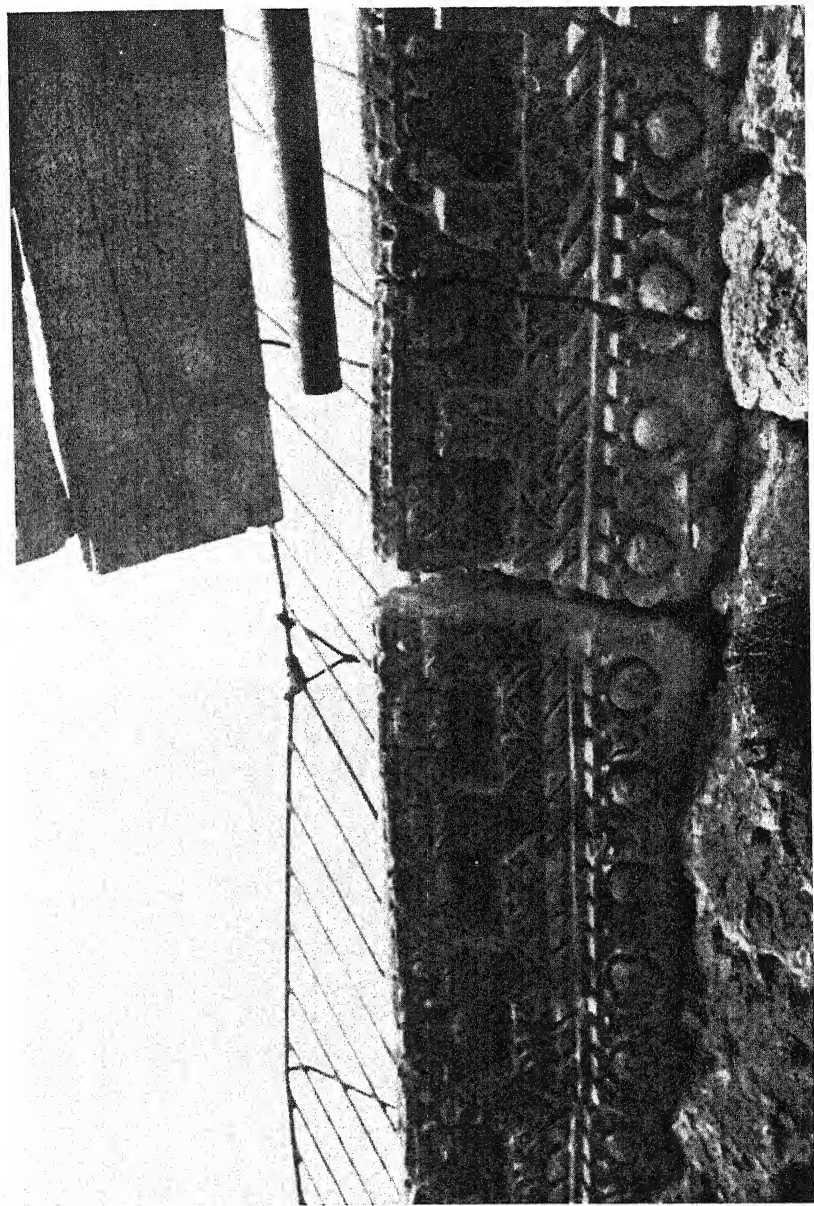
FIG. 33. DISLOCATED BLOCKS OF MAIN CORNICE

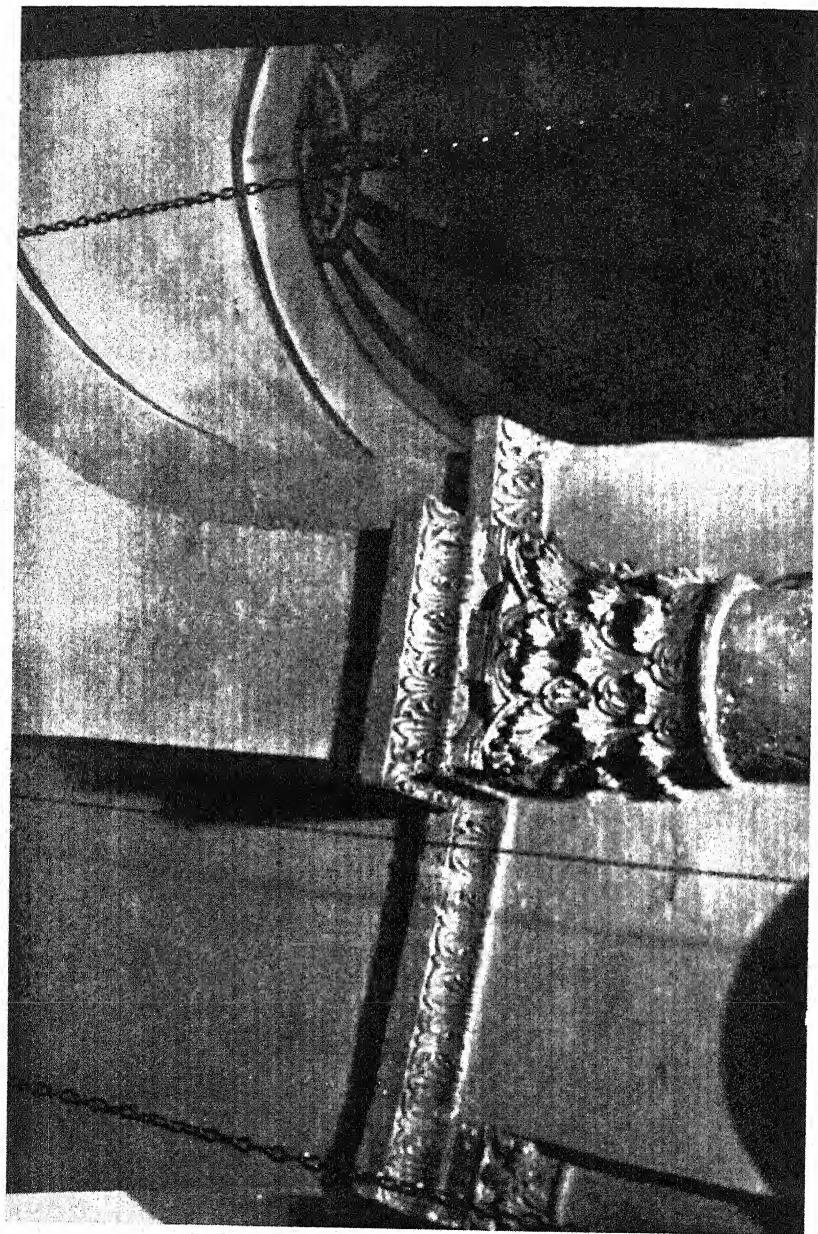
FIG. 42. CAPITAL DESTROYED BY 'RESTORATION' OF 1810. AMBULATORY

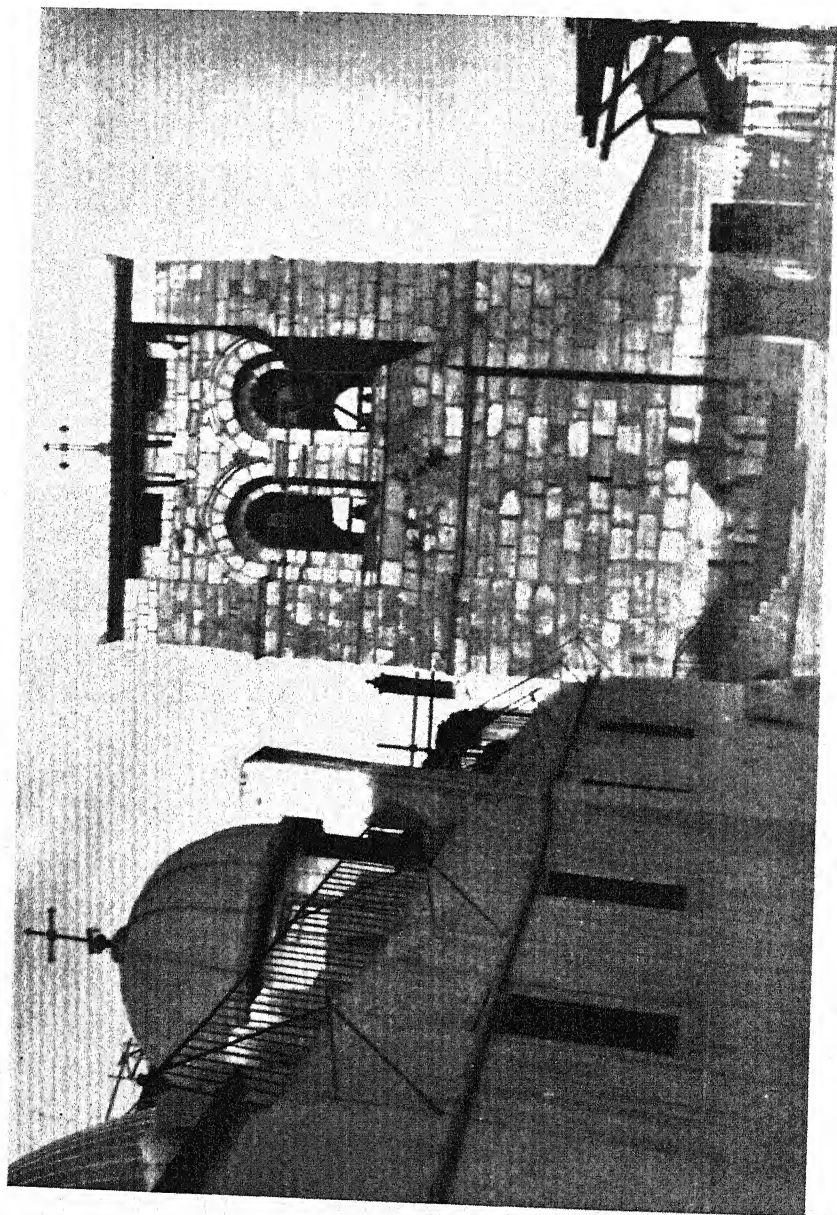
FIG. 57. TOWER FROM W. AND CHAPEL OF CONSTANTINE

At the top the outward inclination is severe, and has affected the surrounding vaults and further walls (see Fig. 57).

Almost at the top is the small Chapel of St. Constantine (see Fig. II, 21); it is within this that the outer Rotunda wall shows its worst leans, which are also easily perceptible in the opposite South wall of the Chapel, which stands on the Convent roof (see Fig. 57). The condition of both walls at this level is serious, as large cracks in the surface stucco of the Chapel show.

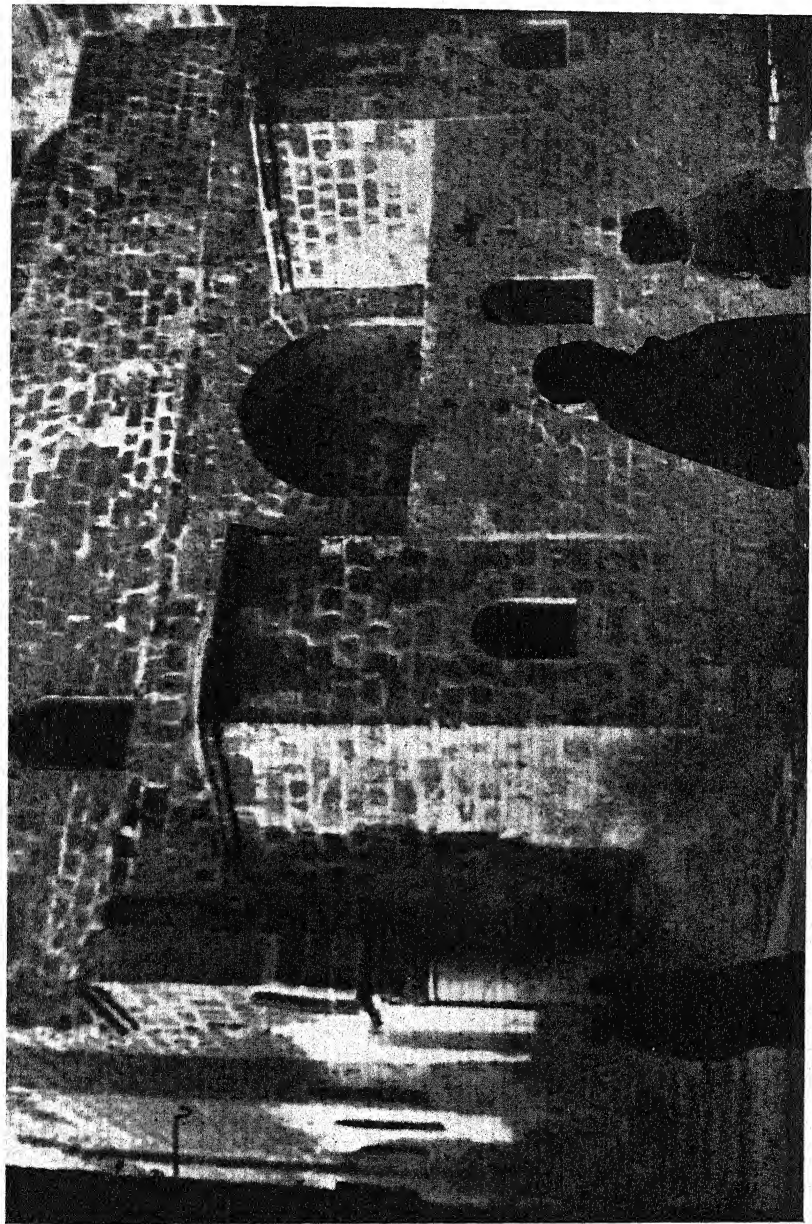
FIG. 60. WEST SIDE OF PARVIS WITH COLUMN OF RUINED ARCADE, AND
APSES OF CHAPEL OF ST. JAMES AND BAPTISTRY

The Baptistry (see Figs. I, 32-II, 19), now partly open to the sky and in part vaulted over at a low level (see Fig. 59), shows little sign of decay in itself, but the thrust communicated to it by the Tower has succeeded in forcing its South wall outwards against the thrust of the vault of the Chapel of St. James (see Figs. 60, I, 33).

A lower series of reinforcements must also be placed in the walls of the old Baptistery and the Chapel of St. James, which leans dangerously towards the street. This band should be carried through into the vaults between the Rotunda and South Transept, and anchored to the main piers.

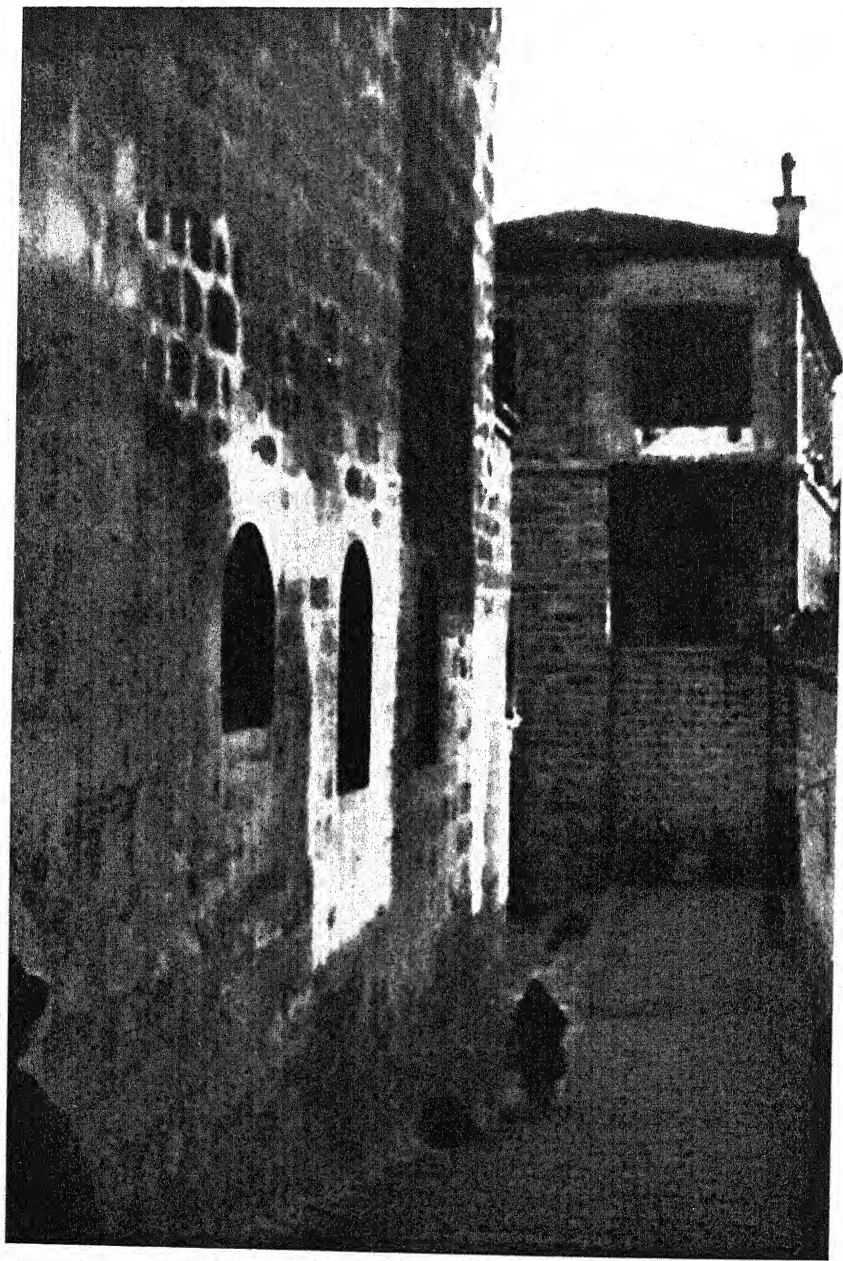
FIG. 61. SOUTH WALL OF CHAPEL OF ST. JAMES

This Chapel is in a state of grave danger, as the lower half of its South wall (see Figs. 61, 62) overhangs the adjoining street

by $22\frac{1}{2}$ centimetres, and the crown of the vault is cracked throughout its length (see Figs. 63, V).

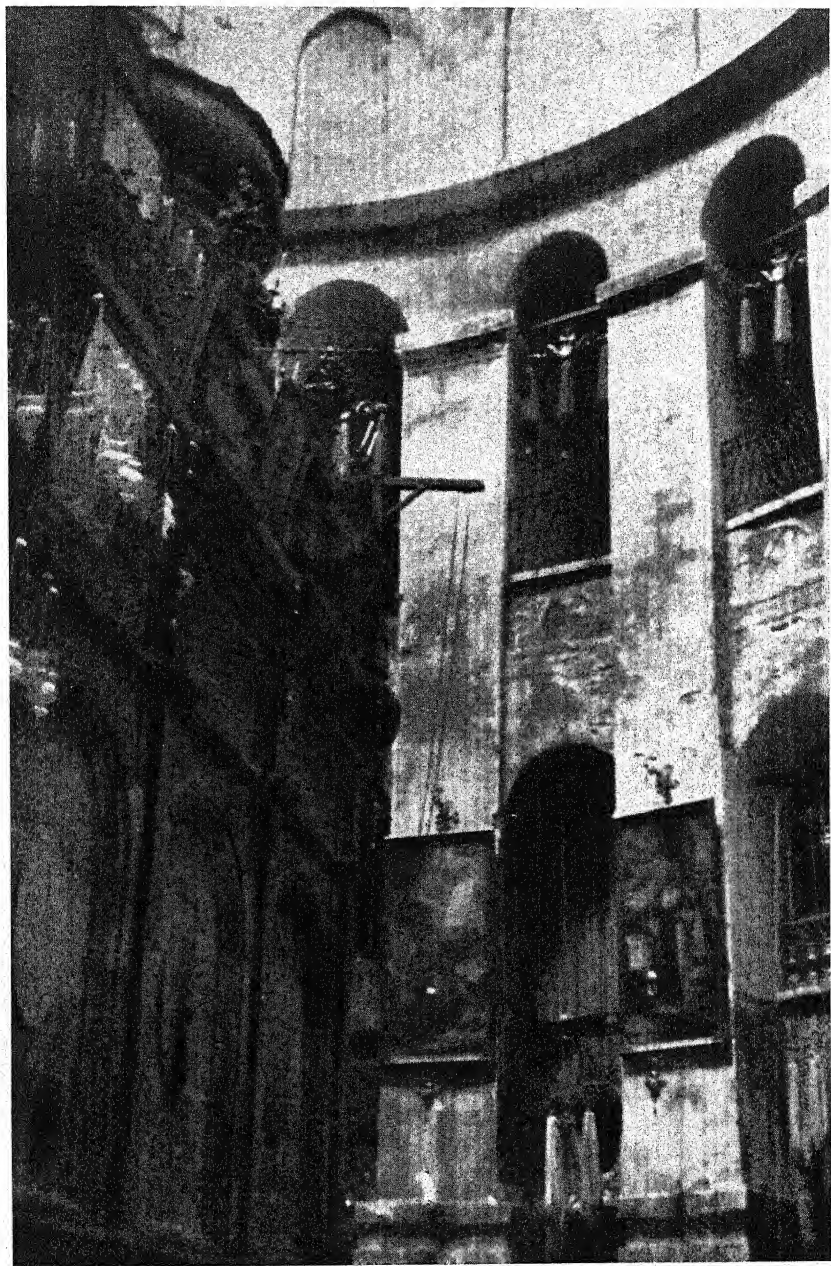
FIG. 64. NORTH-WEST PART OF ROTUNDA

The piers of the main Rotunda (see Fig. I, 13) are now square (see Fig. 64), though they probably enclose as a core the earlier round columns of the building of Constantine Monomach (c. A.D. 1048). The present piers are clamped together with rusting iron (see Fig. 65), are very irregular in shape and size, and are not placed symmetrically beneath the circular drum built in 1867. They are therefore subject to eccentric loading, and all of them show cracks to a greater or less extent; some of these cracks are serious, though certainly due to earthquake shock as well as to thrusts (see Fig. 66).

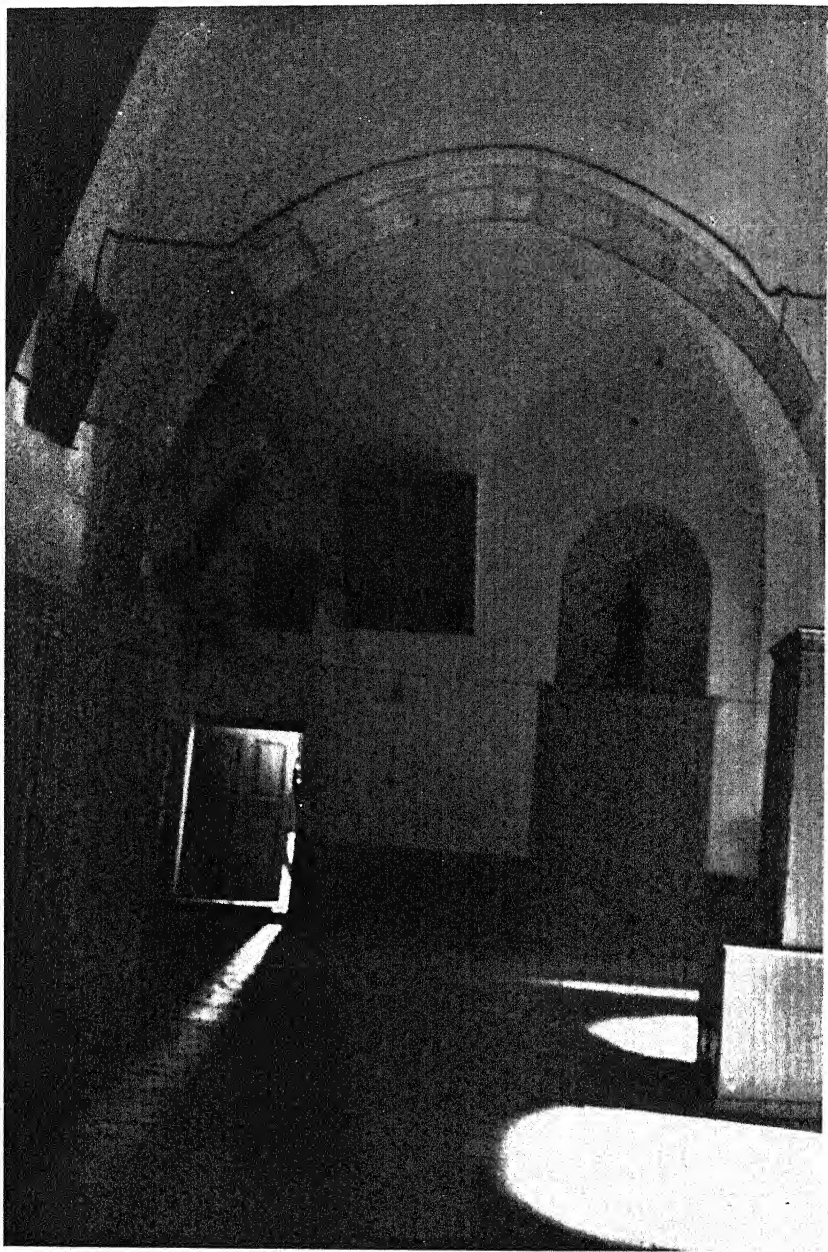
FIG. 67. FRANCISCAN UPPER GALLERY OF ROTUNDA

The galleries of the Rotunda (see Fig. 67) surround the main piers, and are enclosed by a circular wall, whose lower portions date from Constantine's original Anastasis (see Fig. 68). This circular wall leans outwards owing to the thrusts of the gallery vaults and the communicated thrusts of the cone which covered the central space prior to 1808.

A series of tie-bars across the arches of the upper Rotunda gallery, connected to a band of reinforcement in the outer wall may also be required to stabilize this wall and the inner colonnade.
